## Failure of Defences

The current defences along Southsea Seafront have a residual life of less than 10 years – this is discussed in the ‘Current Standard of Protection’ resource in the ‘Resources’ section of this website. The end-of-life conditions of the defences mean that there has been an increase in failures along the frontages in Southsea following winter storm events.

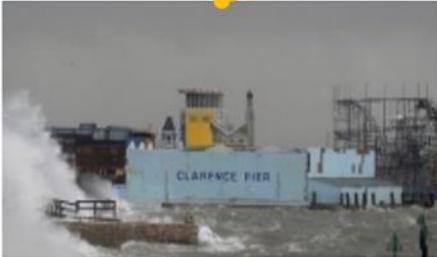
### Frontage 1 – Long Curtain Moat

Characterised by historic fortifications that make up the Scheduled Ancient Monument (SAM) of Long Curtain Moat, Kings Bastion, and Spur Redoubt (built c.1665). The defence in this area is primarily masonry facing battered back at a slight angle with a concrete toe beam visible in places.

During the Winter 2013/14 storms the frontage suffered extensive damage that led to the critical failure of a section of the defence.

Maintenance and emergency works to date		Cost
2009	Pointing work was undertaken to the Stone Masonry wall at Clarence Beach immediately west of Clarence Pier	£19,000
2014/2015	Major works to repair a 10m breach in the seawall and damage to the west of Clarence Pier	£61,500

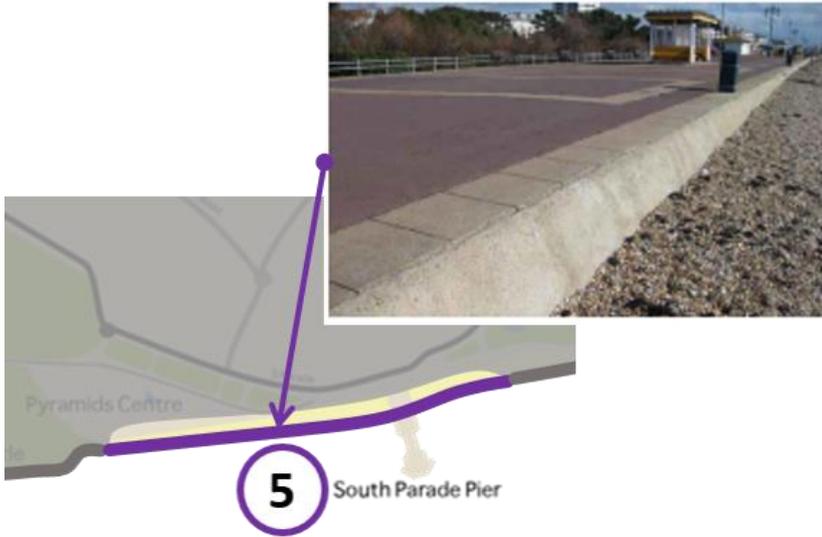
Frontage 5 – South Parade

To the rear of this defence it is mostly residential and is known as the Great Morass. The ground levels fall away from South Parade towards the Great Morass and, at the lowest point, it is 4m below crest level.

The defence to the west, and fronting the Pyramids Leisure Centre, have been temporarily repaired after a critical failure during the winter 2015/16 storms.

The defence is a stone work seawall with a concrete capping beam along its crest. A promenade runs behind the seawall at crest level.

Maintenance and emergency works to date		Cost
2014	Repairs and resurfacing to the ageing promenade along this frontage are regularly undertaken. Flooding to the Pyramids Leisure Centre and swimming pool plant room occurred due to wave overtopping. The cost was in excess of £1million of flood damage (met via insurance claims), including the addition of flood boards to the plant room.	In excess of £1million of damage
2015	During the 2015 winter storms, 30m of the defences in front of the Pyramids failed. Emergency works were undertaken.	£660,000
2016	Overtopping and flooding either side of the Pyramids during Storm Katie resulted in damage to the infrastructure and operation of the building.	-

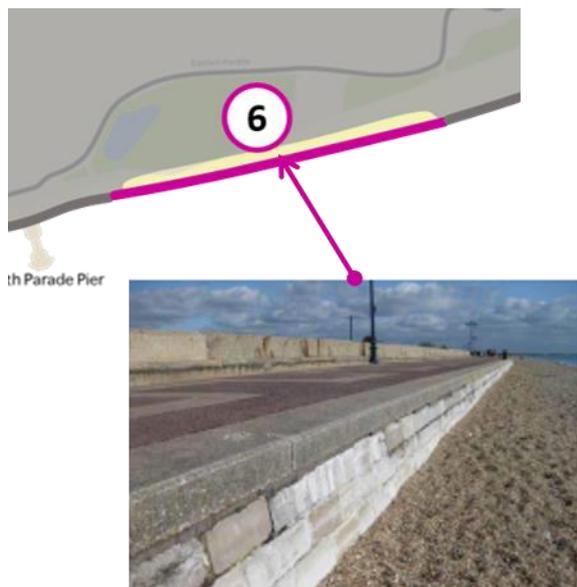
Frontage 6 – Canoe Lake

The frontage is a promenade fronted by a wide shingle beach which narrows in the west due to a change in defence. Canoe Lake provides valuable open space and recreational/tourist facilities – it is low-lying with a densely developed urban area behind.

The defence here is a stone work seawall with a concrete capping beam. A promenade runs behind the seawall at crest level and is approximately 8m in width. To the rear of the promenade is a curved concrete splash wall approximately 1m in height rising above the adjacent road.

Maintenance and emergency works to date		Cost
2010	Work has been undertaken to apply a render coating to the splash wall at the rear of the promenade.	-
2014	Wave overtopping and loss of beach materials has led to road closures and the need for shingle clearance.	The cost is met by the PFI Highways contract.
