## Failure of Defences

The current defences along Southsea Seafront have a residual life of less than 10 years – this is discussed in the ‘Current Standard of Protection’ resource in the ‘Resources’ section of this website. The end-of-life conditions of the defences mean that there has been an increase in failures along the frontages in Southsea following winter storm events.

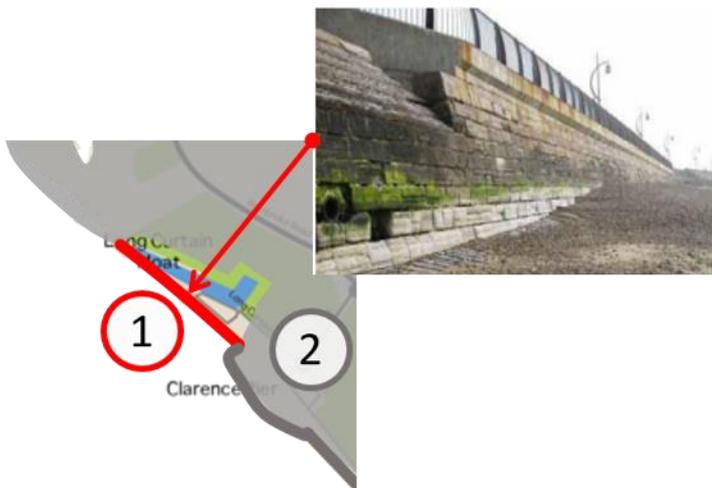
The current asset management protocol, which is in line with the Shoreline Management Plan, is to maintain and repair Southsea’s flood and erosion defences. Annual inspections of the condition of all flood and erosion assets are undertaken following the Environment Agency’s guidance. Due to the poor condition of many of the assets, they are required to undergo a quarterly inspection. Additionally, following any storm event, a ‘post-storm survey’ is undertaken to inspect the assets. This records any damages or changes to their condition and remedies any defects. Some assets are fronted by shingle beaches, which are reducing in volume, causing significant risk of undermining the defences (as seen at the Pyramids in winter 2015). Beach shingle deposited on Southsea’s promenades, slipways and roads are also recycled on to the beach. No current Beach Management Plan is developed, however Beach Management studies have been undertaken through the Shoreline Management Plan, the scoping stage of the project, and the Regional Monitoring Programme. Annual asset inspection and maintenance costs for Southsea are approximately £75,000. Emergency repairs between 2012-2016 have cost in excess of £900,000.

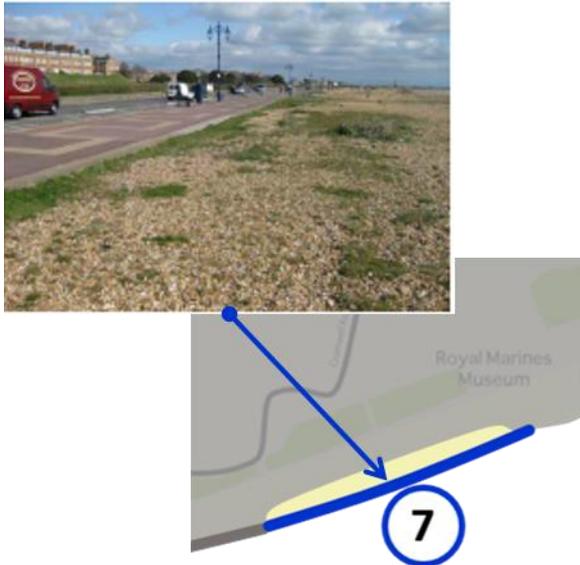
### Frontage 7 – Eastney Barracks

The promenade is fronted by a wide open shingle beach which can be accessed via the ‘Cockleshell Heroes’ D-Day slipway. There are a number of historically important Royal Marines military establishments and Grade II listed lamp columns.
